20-251E

Re: **World Trade Center**
New York, New York

One World Trade Center

Subgrade (Parking & Storage Areas)

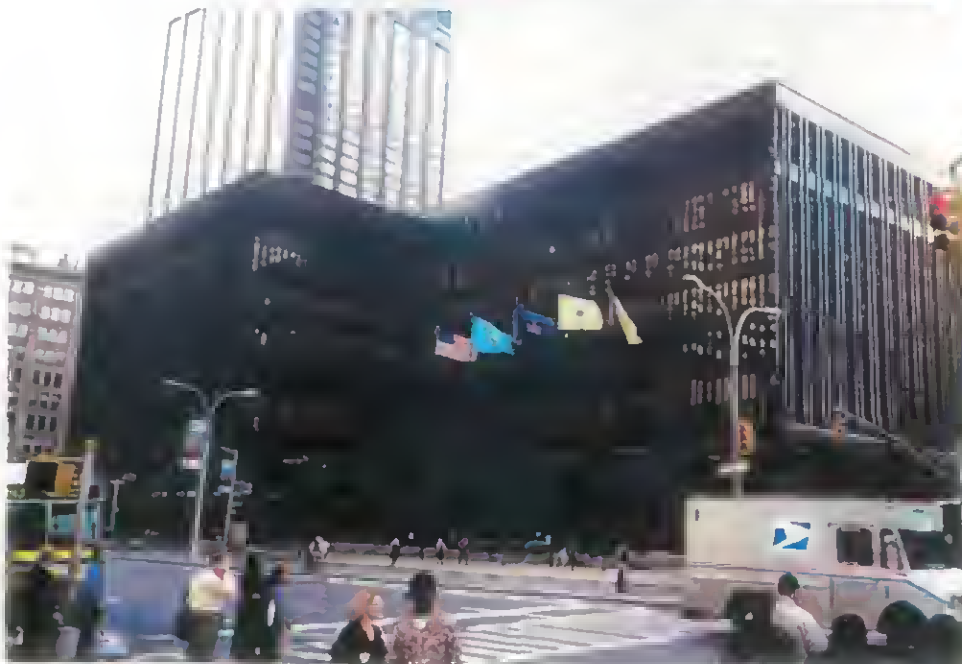
Photograph 7

**Aluminum
cladding conceals
steel truss to
support
cantilever at 4th
floor overhang**

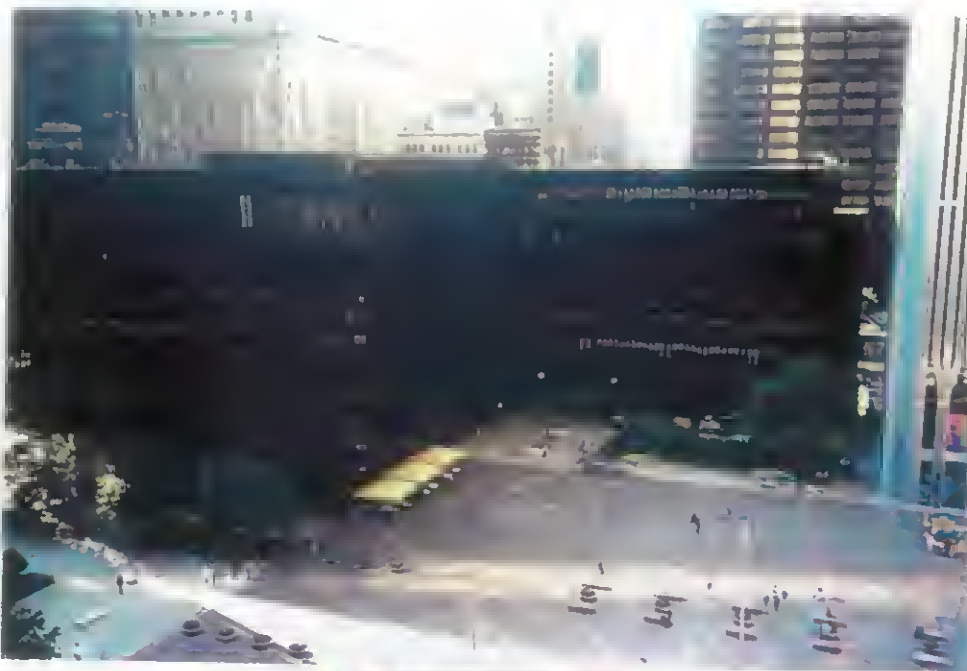
Photograph 8

**East and north
elevations**

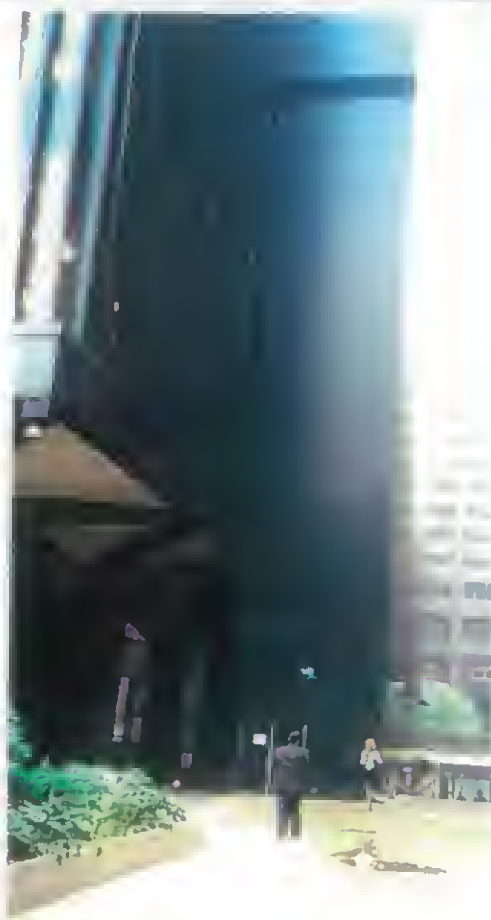
Photograph 9

North and west
elevations from
roof of 5WTC

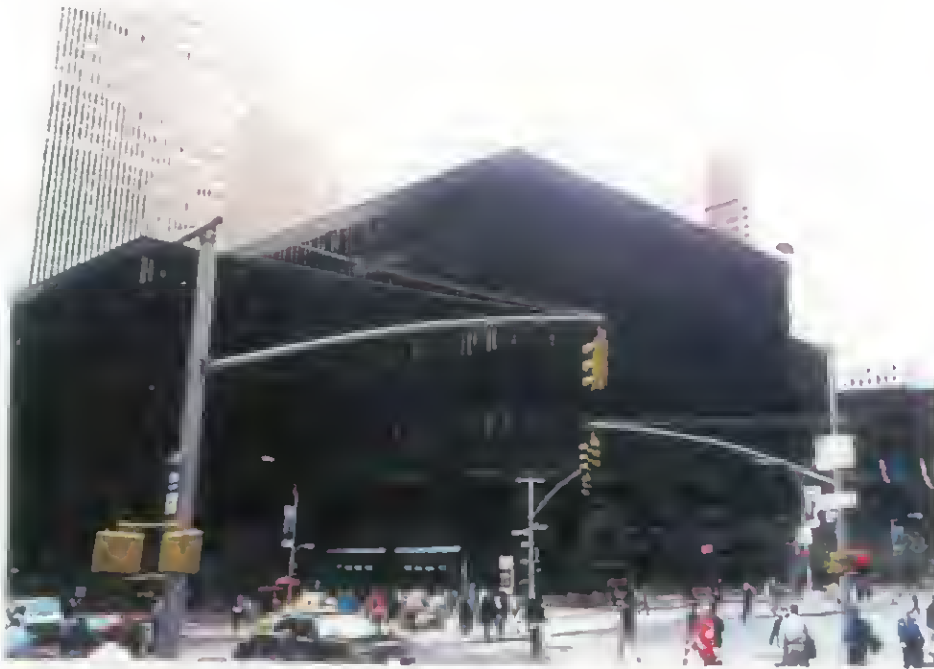
Photograph 11

West and south
elevations

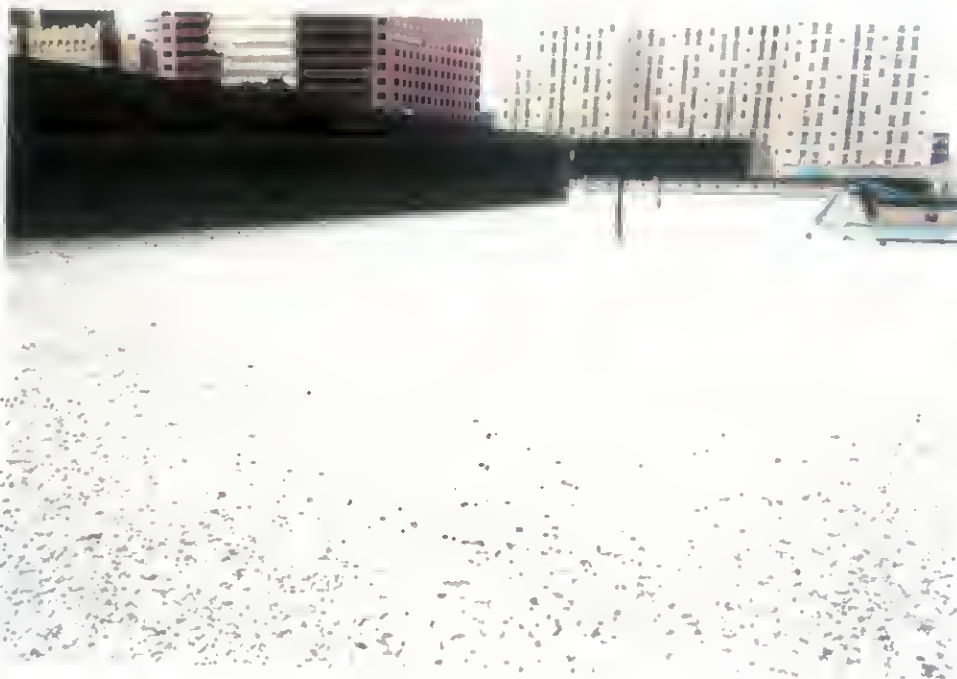
Photograph 14

Roof layout
overview from
tower

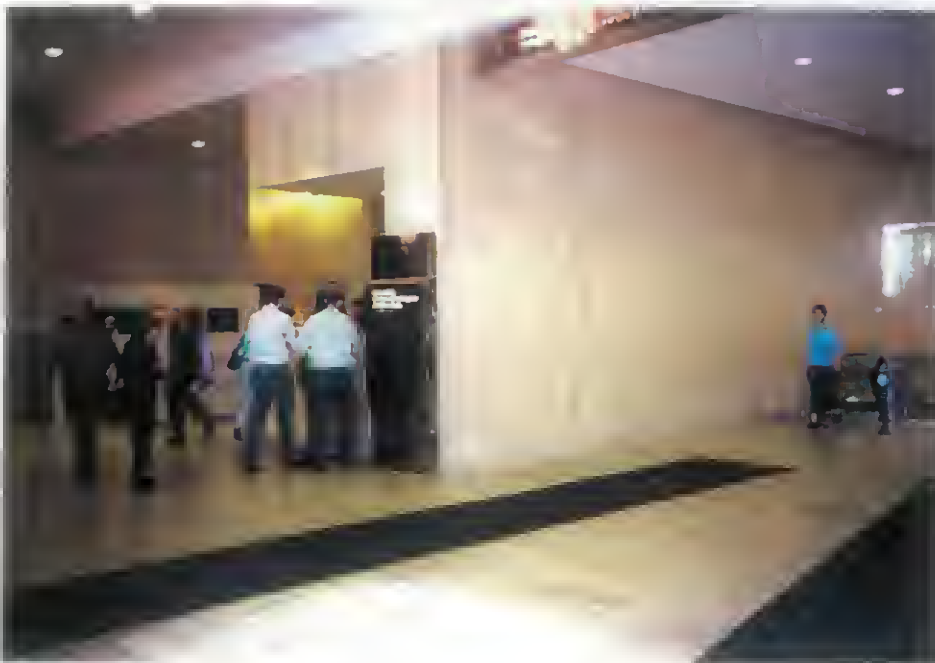
Photograph 17

**Concourse level
elevator lobby**

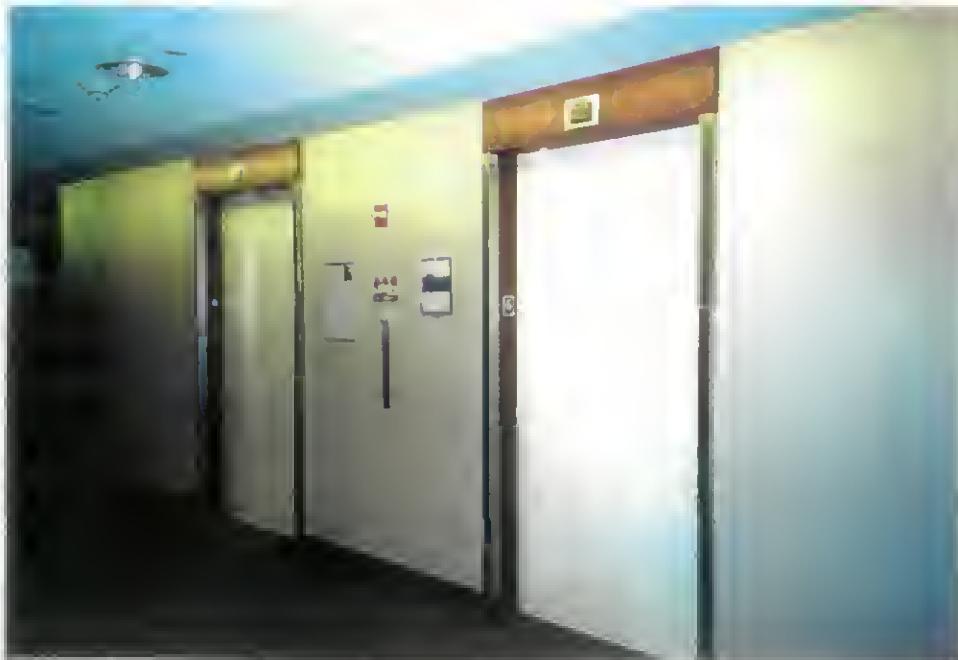
Photograph 19

**Plaza level
elevator lobby**

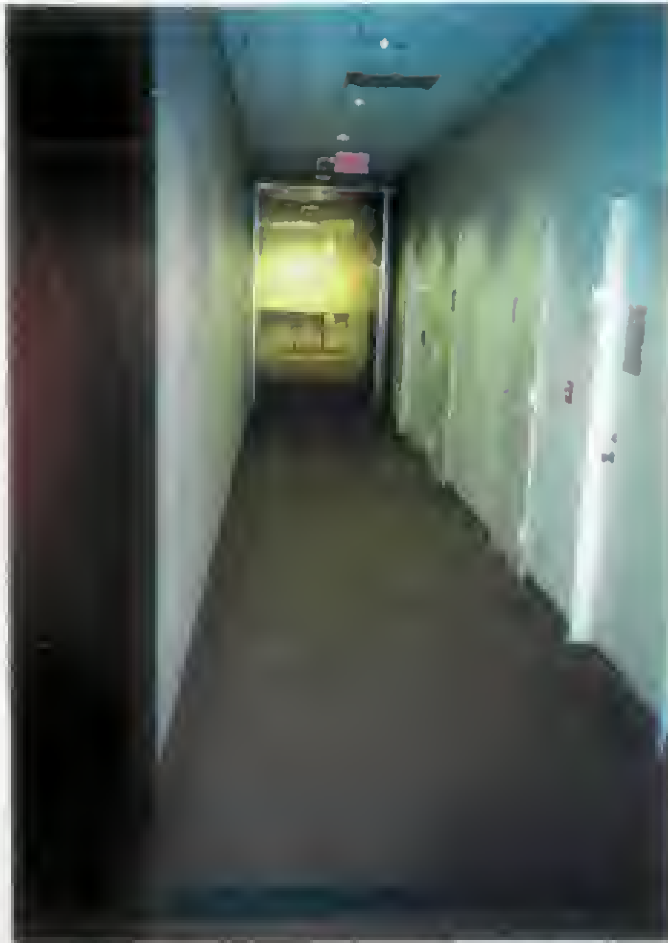
Photograph 20

**Typical office
floor elevator
lobby**

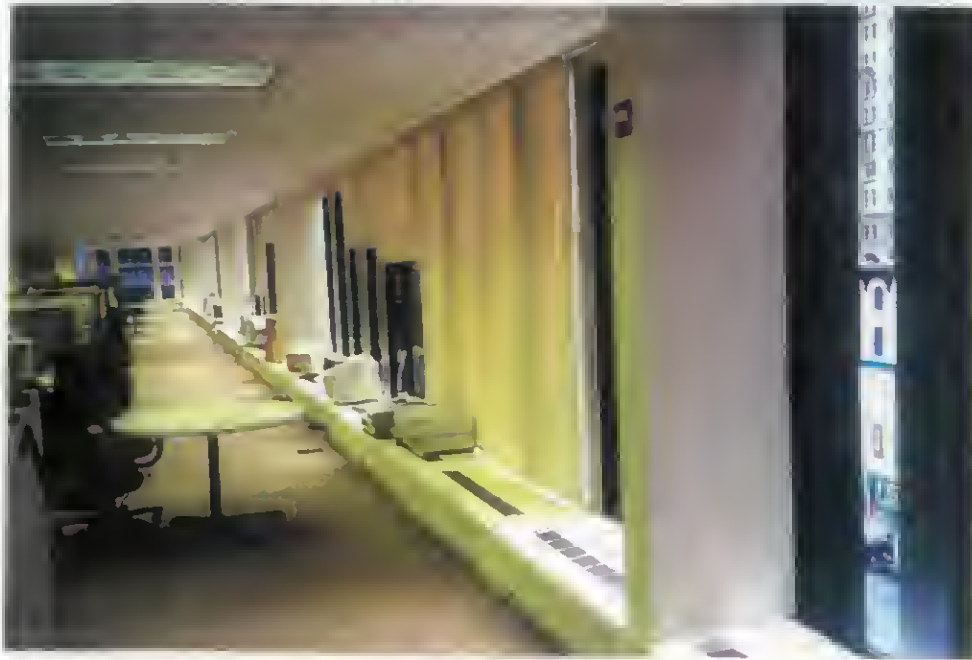
Photograph 21

**Office floor
corridor finishes**

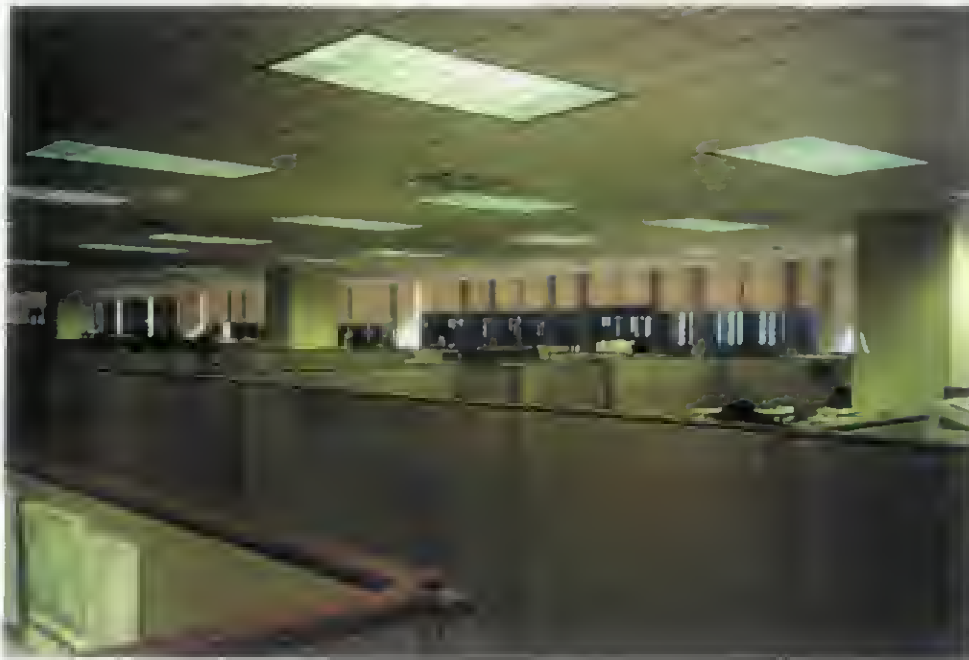
Photograph 22

**Office space
along window
wall**

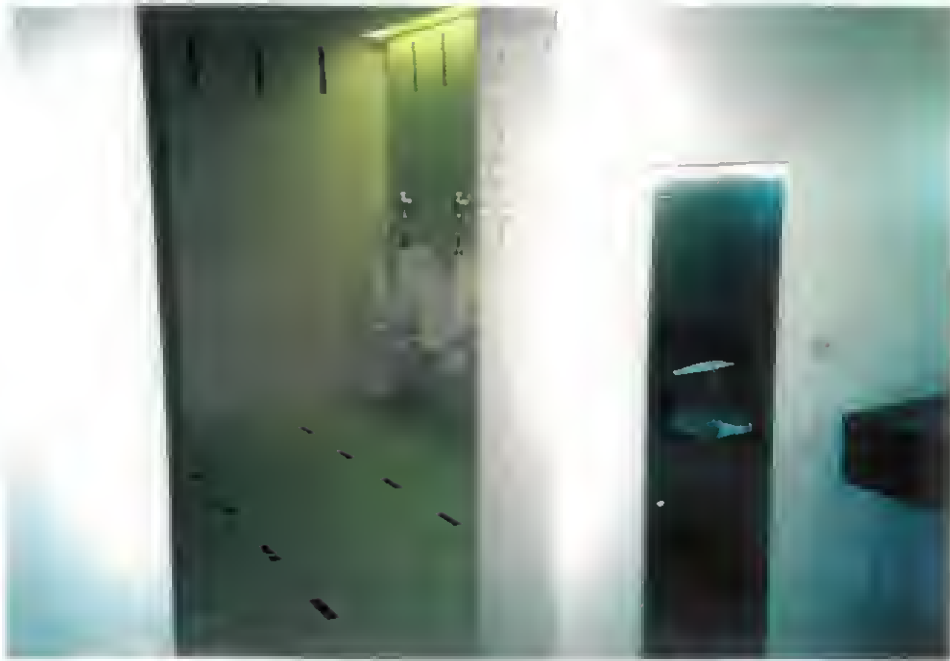
Photograph 24

**Typical rest
room finishes**

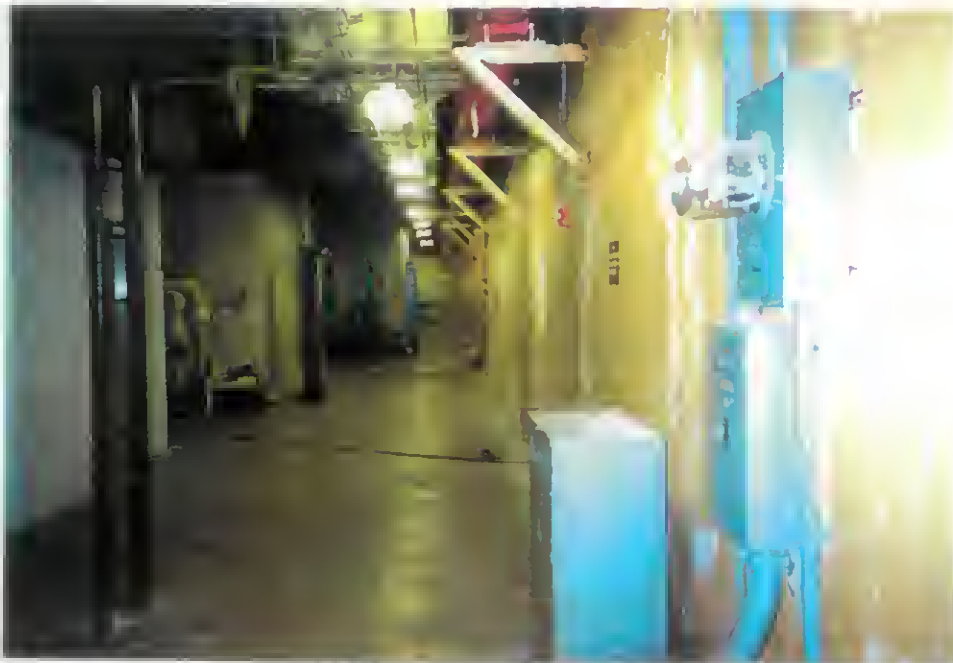
Photograph 27

**Mechanical
equipment room
finishes on 9th
floor**

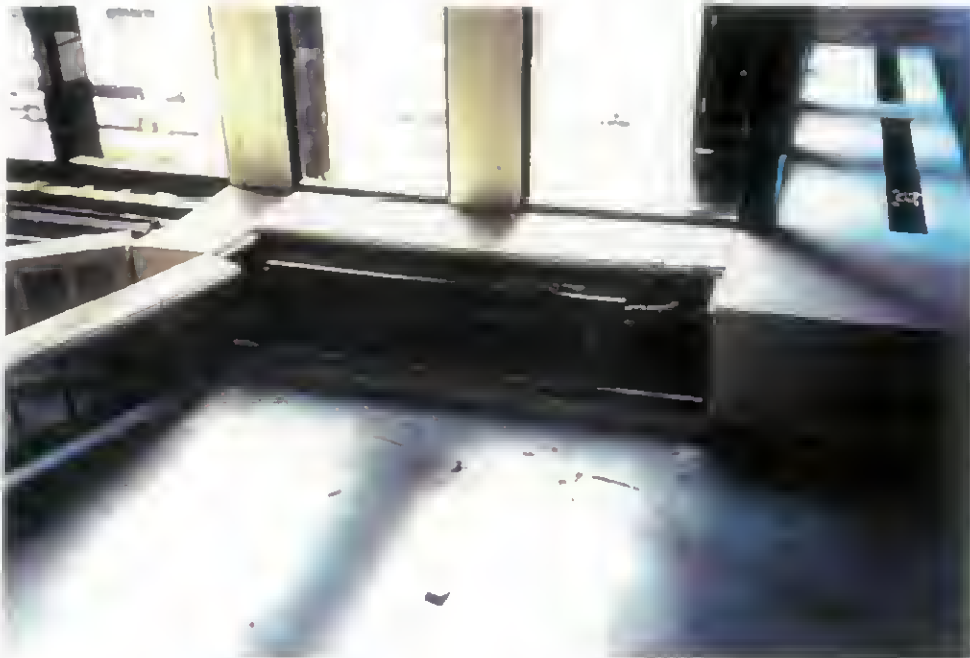
Photograph 28

**Mechanical
equipment room
finishes on 9th
floor**

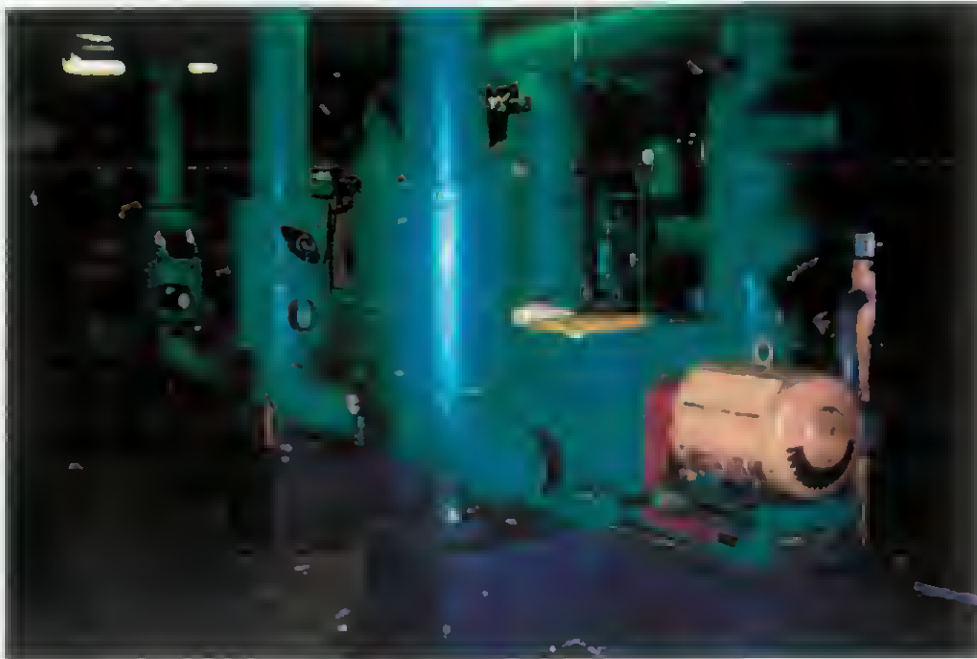
Photograph M2

Air handling unit
located in the
3rd floor
mechanical room

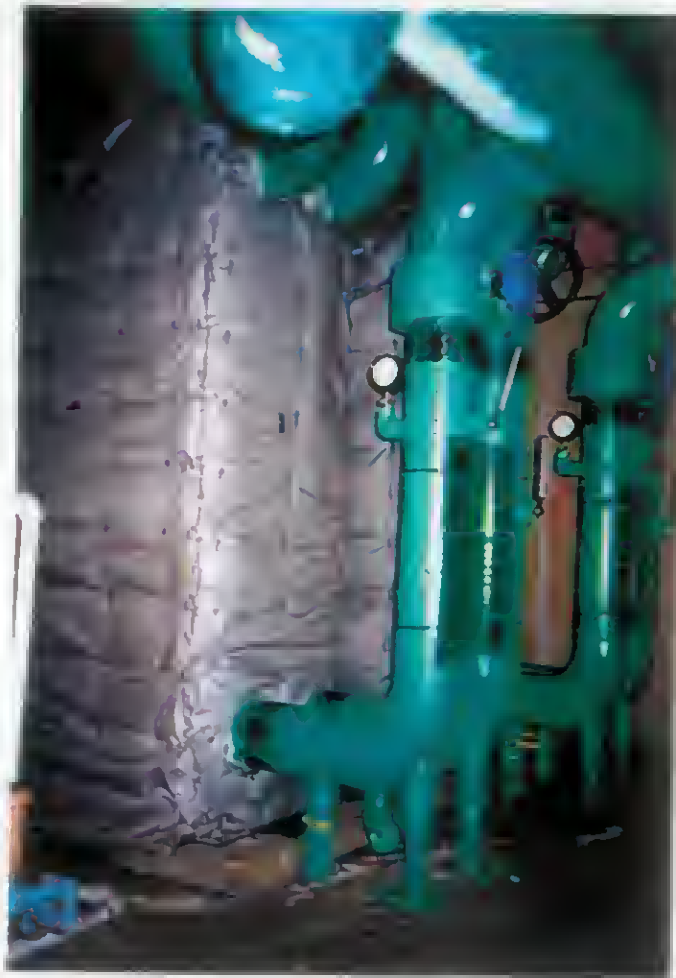
Photograph M3

**Chilled water
pumps located in
the B1
mechanical room**

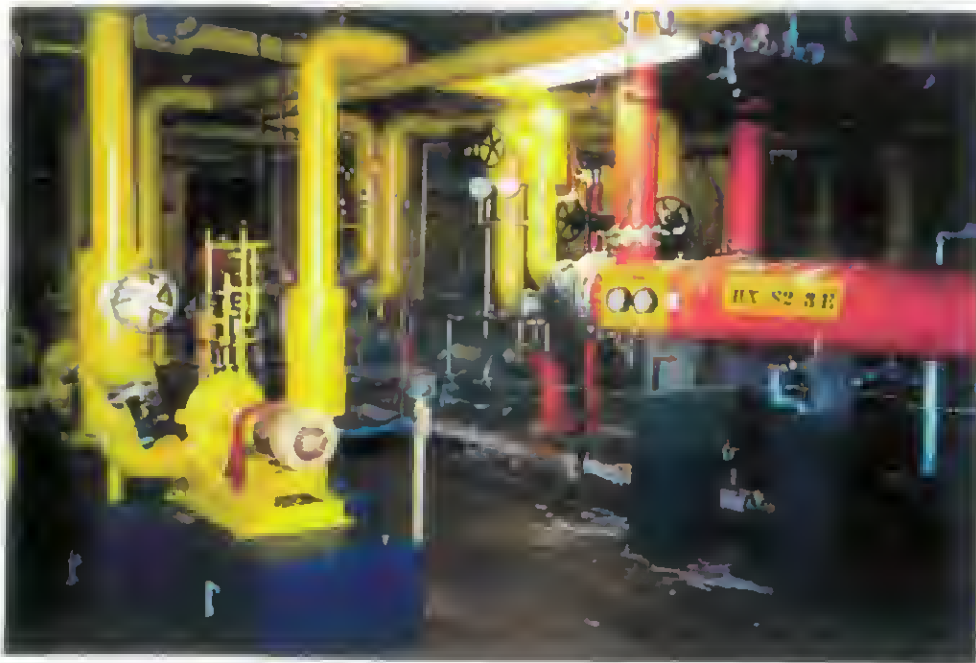
Photograph M5

Condenser water
supply and
return lines for
tenant
supplementary
air conditioning

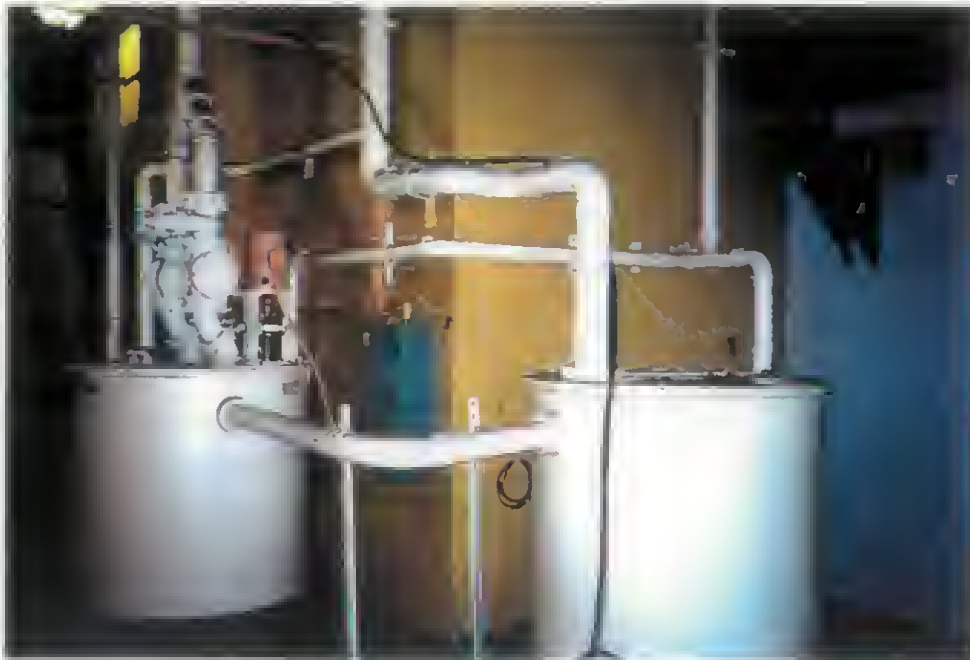
Photograph M6

Heat exchanger
and circulating
pump for heating
hot water

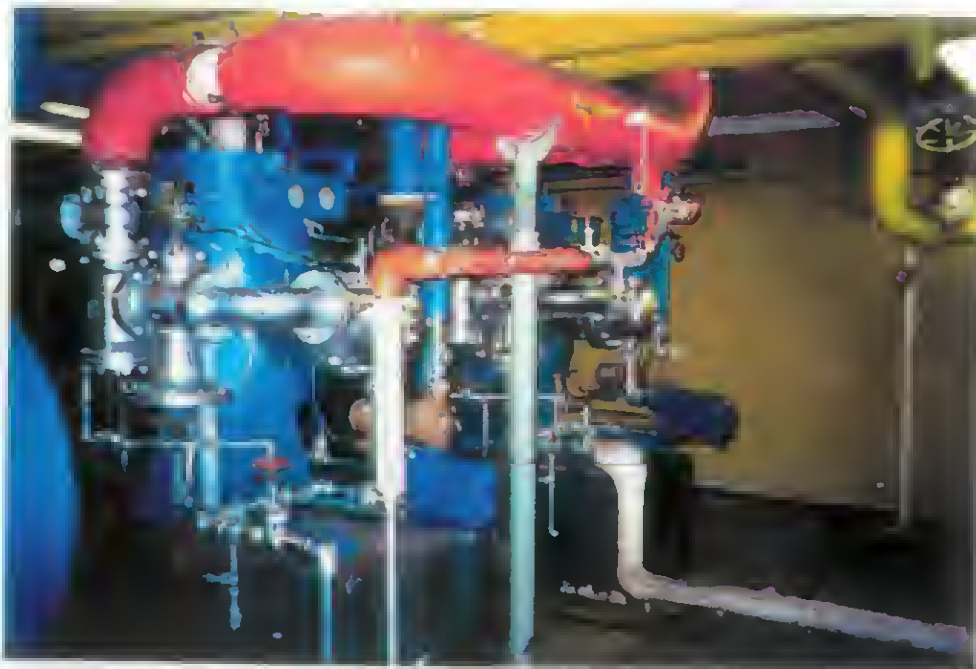
Photograph M7

**Ejectors and
tanks located in
the B1
mechanical room**

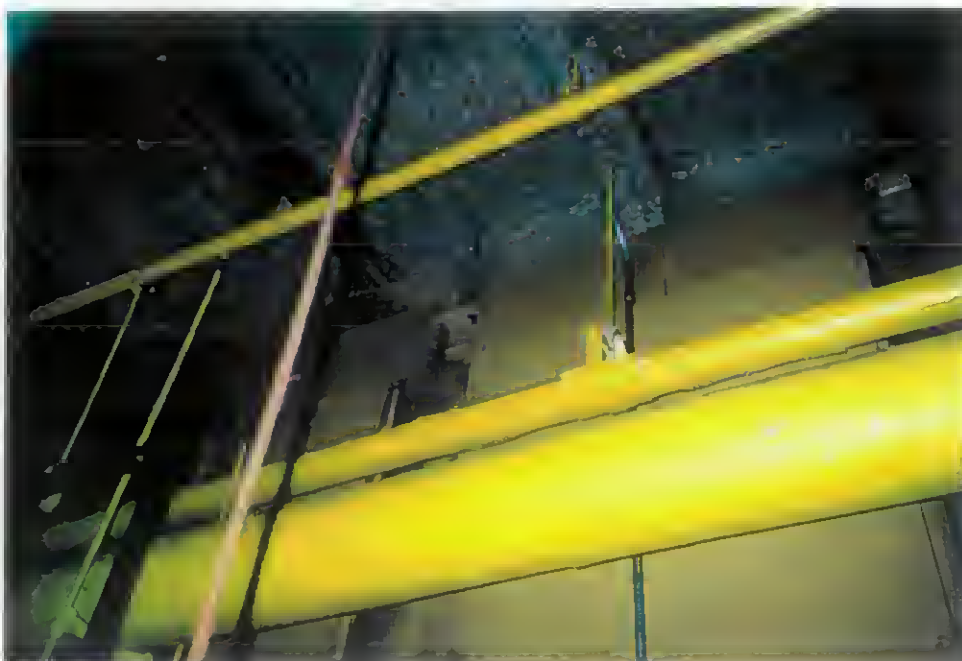
Photograph 2

**Existing
structure at 8th
floor below the
MER. Spray-
applied
fireproofing and
rigid panel sound
insulation are
visible**

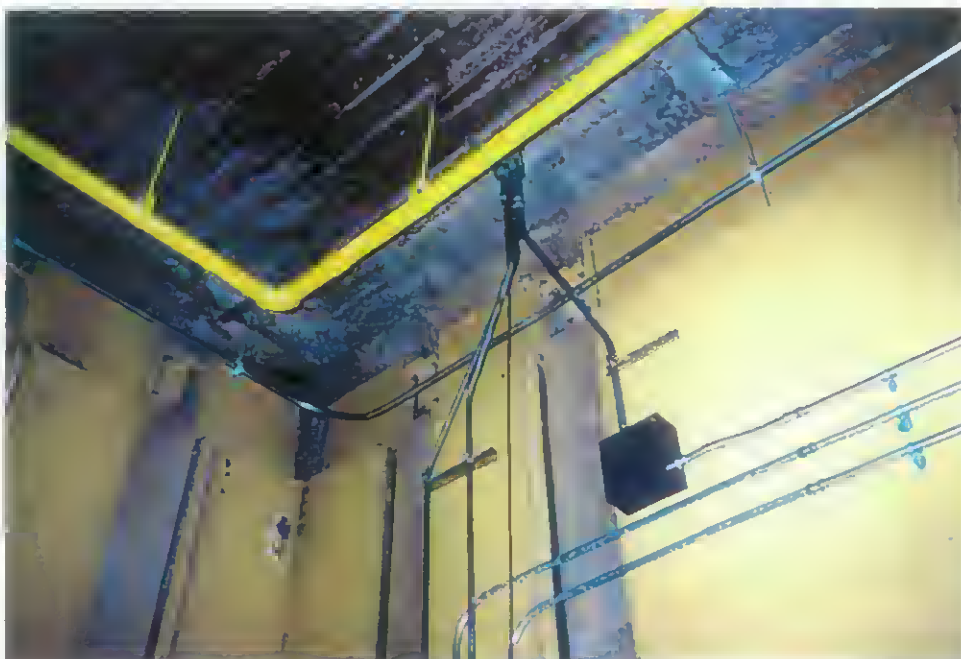
Photograph 3

Roof deck
structure with
lally-column
supports of
exterior wall
visible at 9th
Floor MER

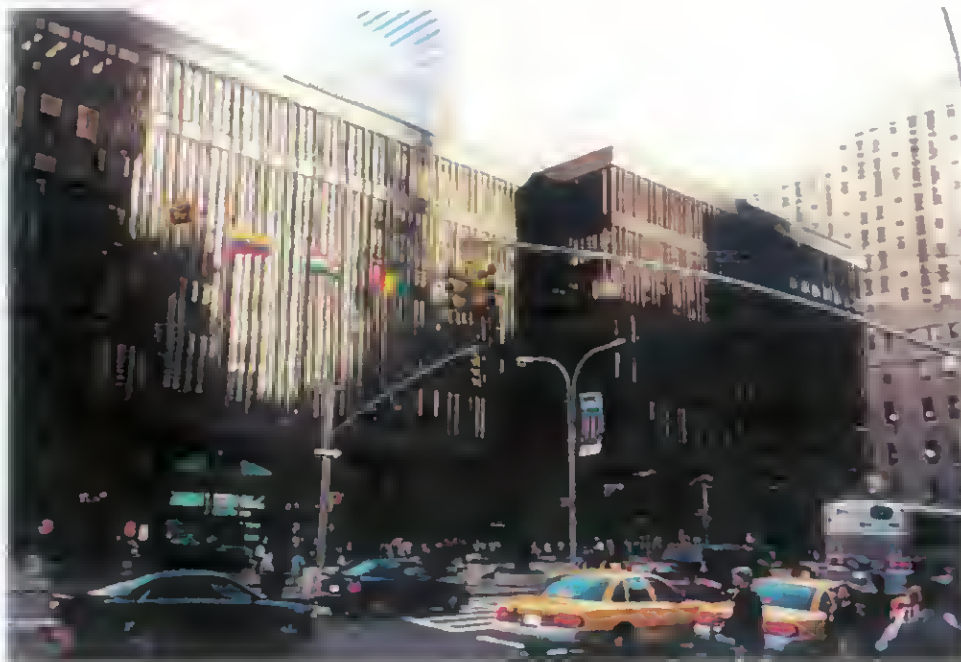
Photograph 6

Structure of B1
Level at loading
docks which also
services 4WTC

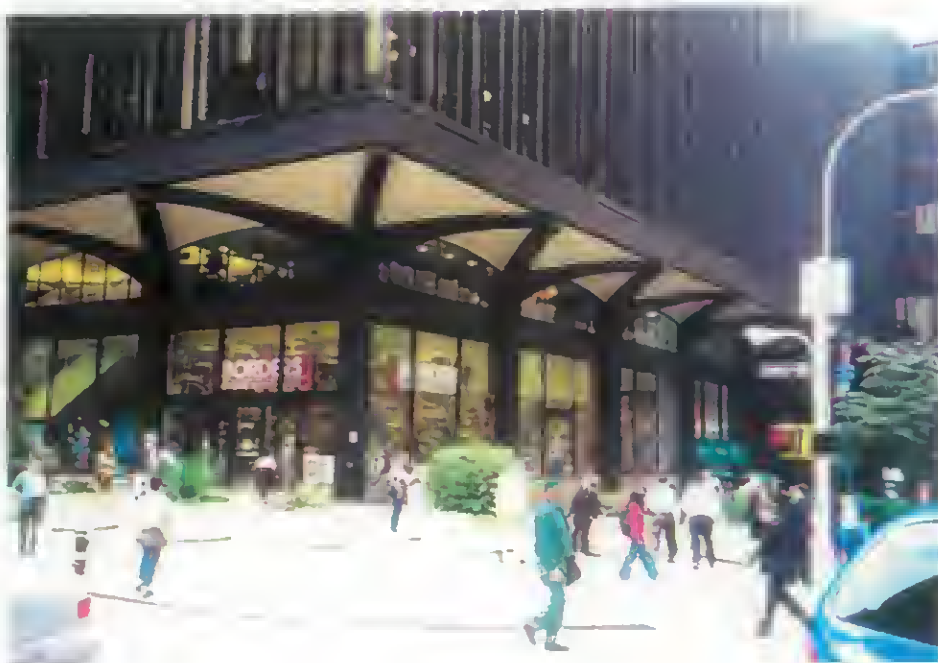
Photograph 7

East elevation

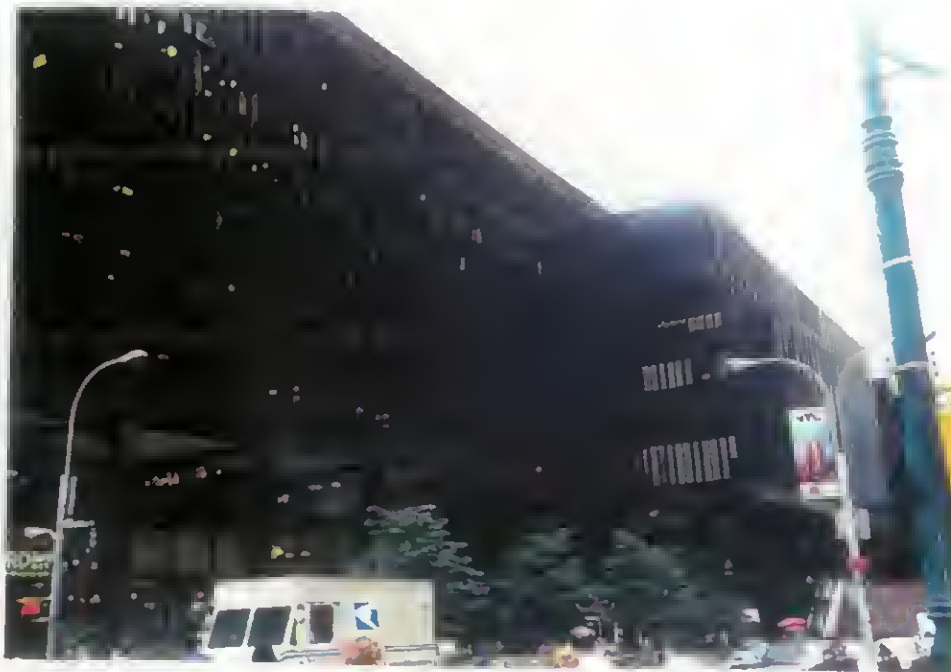
Photograph 8

**Northeast corner
from Church
and Vesey
Streets**

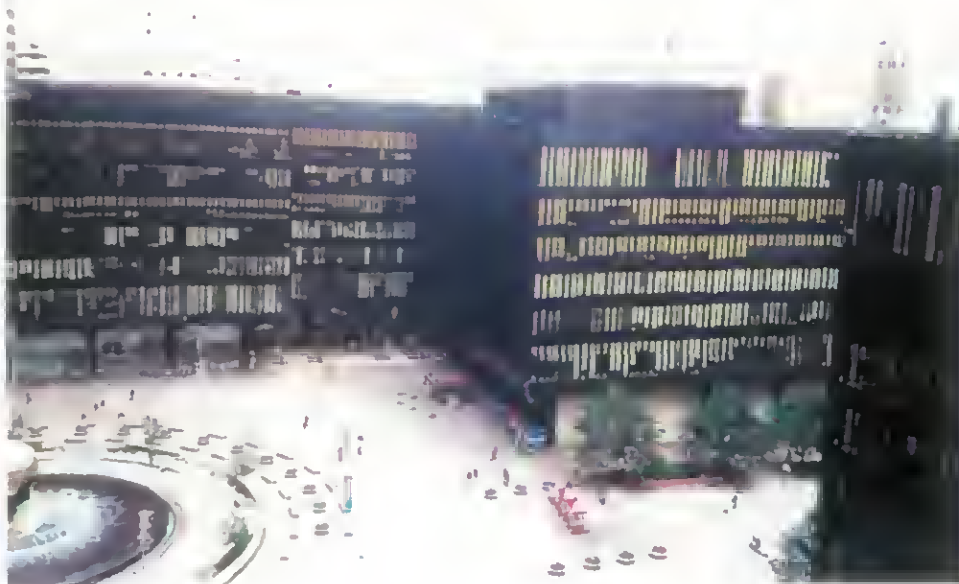
Photograph 9

North elevation

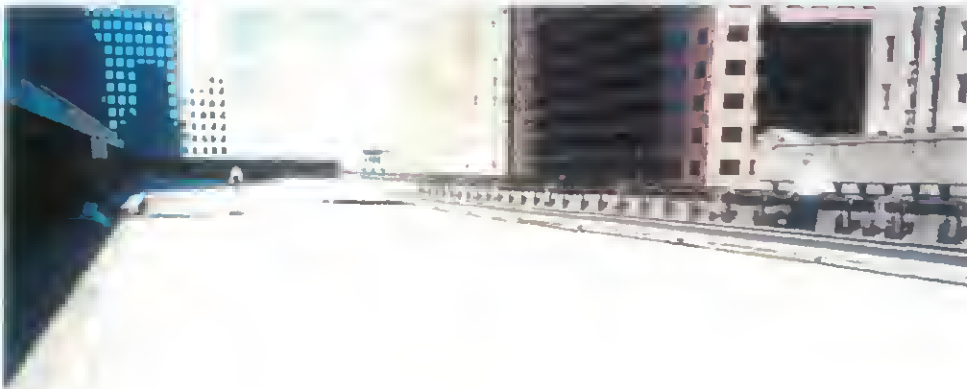
Photograph 11

**Roof layout
overview from
tower**

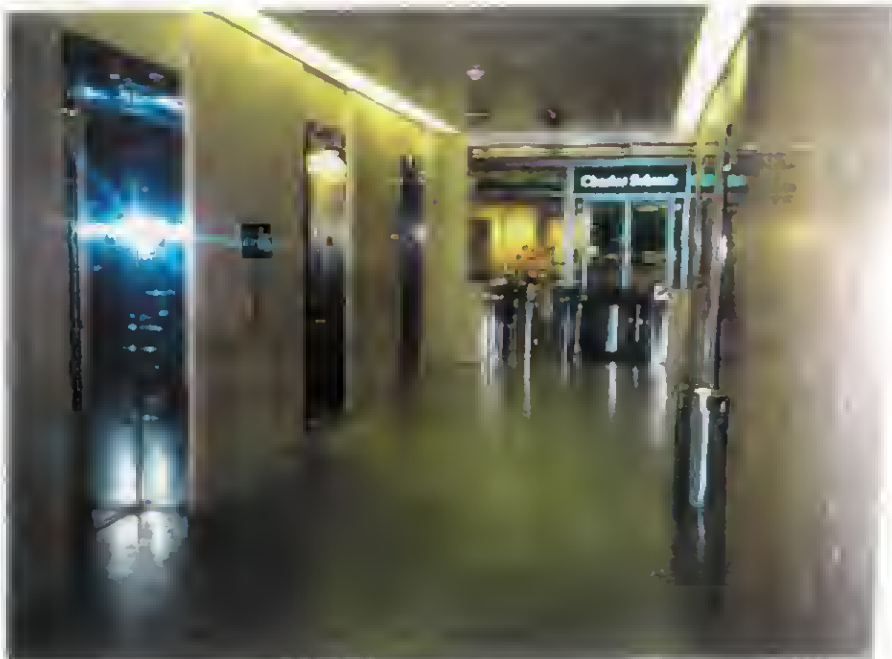
Photograph 17

Concourse level
stair and ramp
entrance from
retail mall

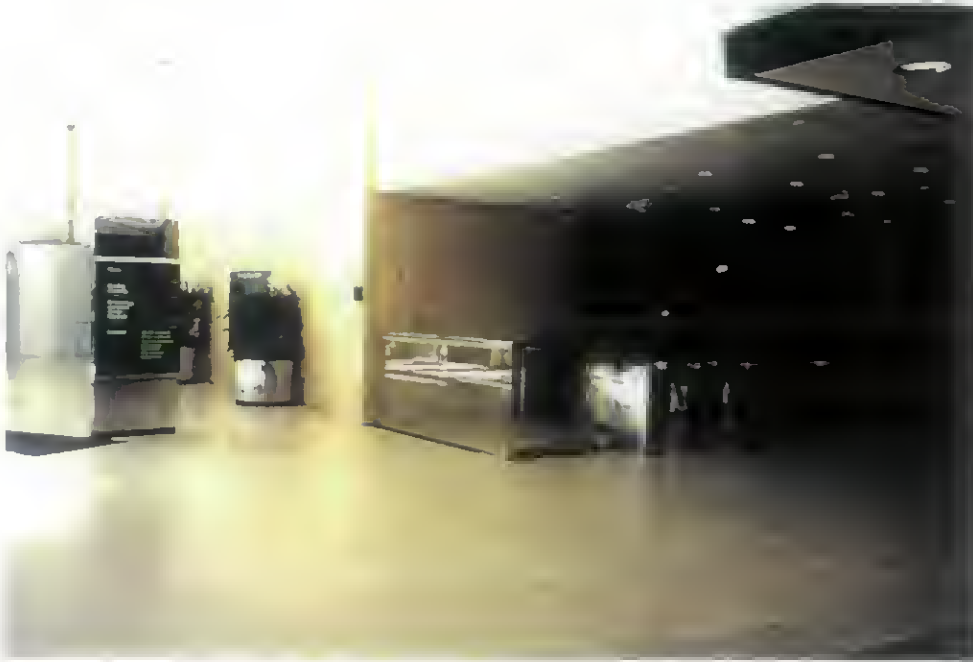
Photograph 18

Concourse level
entrance

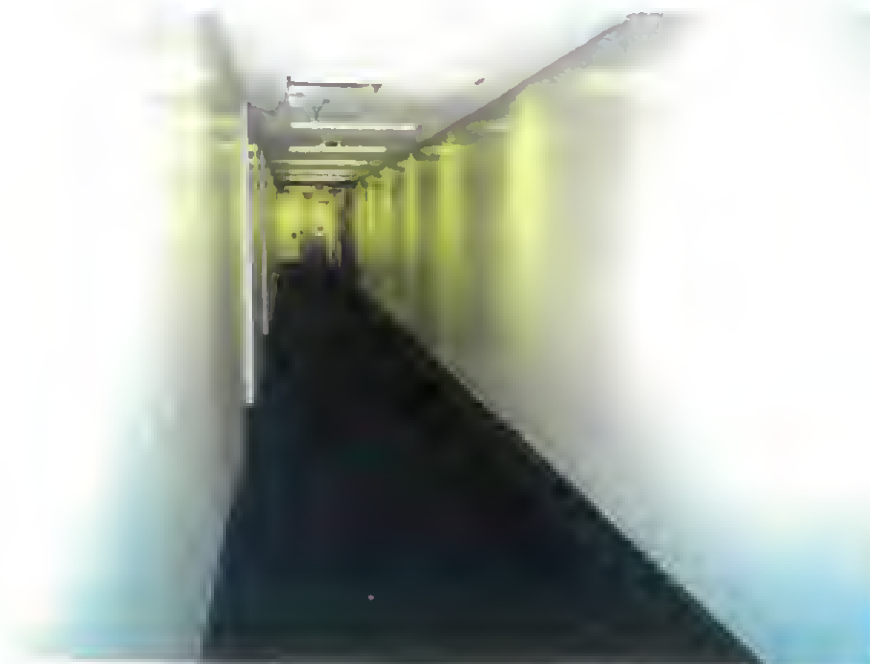
Photograph 19

Plaza level lobby

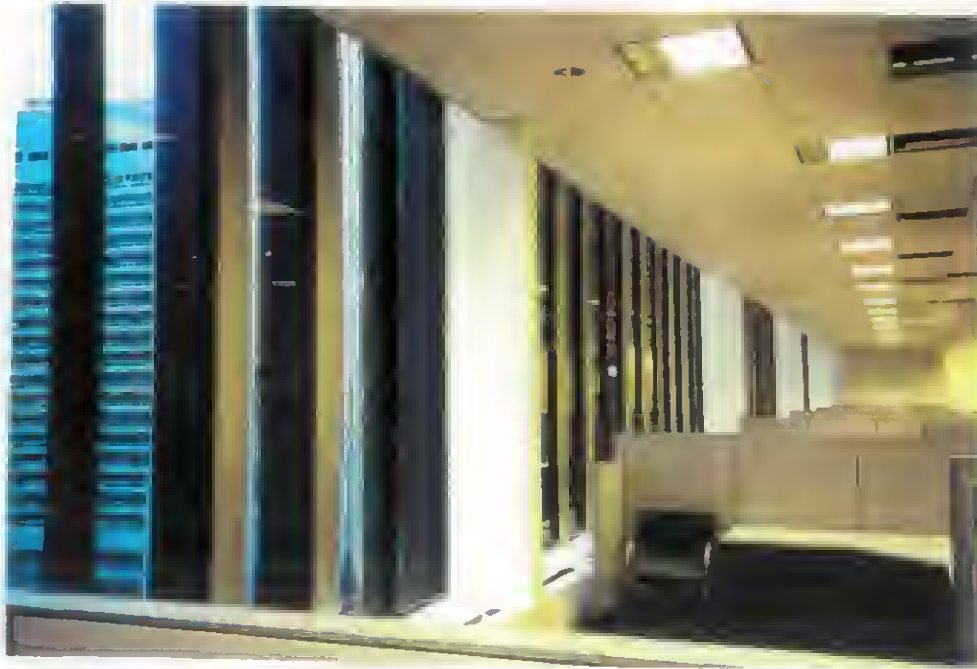
Photograph 20

**Office floor
corridor finishes**

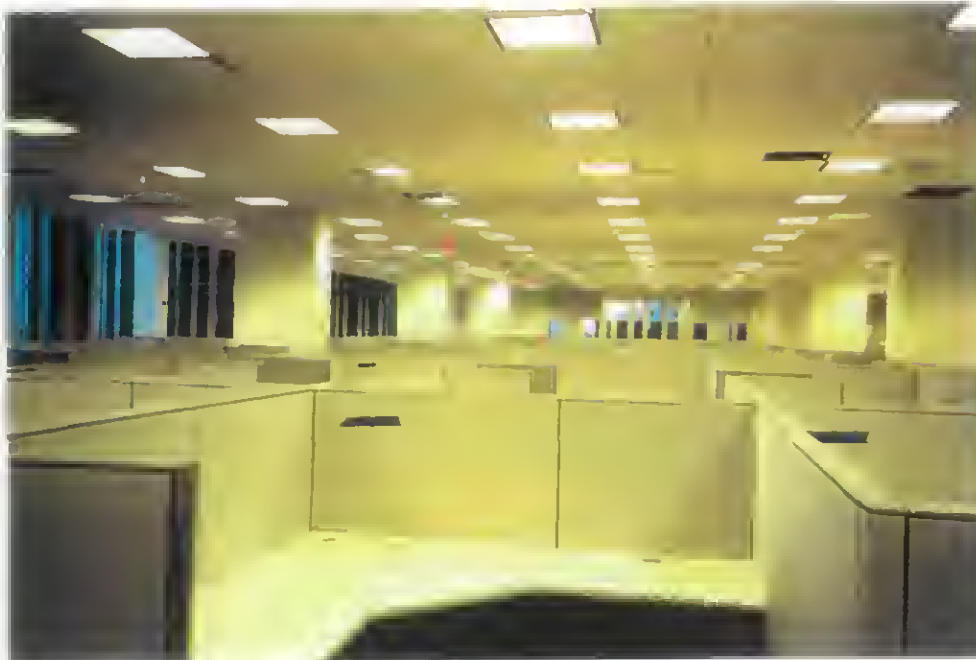
Photograph 21

Office space
along window
wall

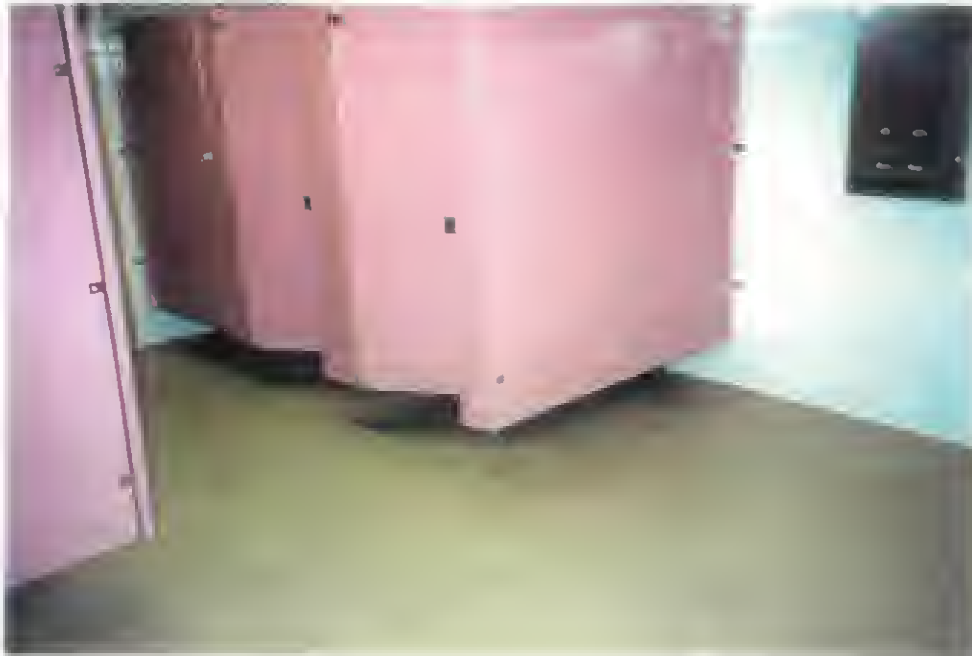
Photograph 22

Representative
office space

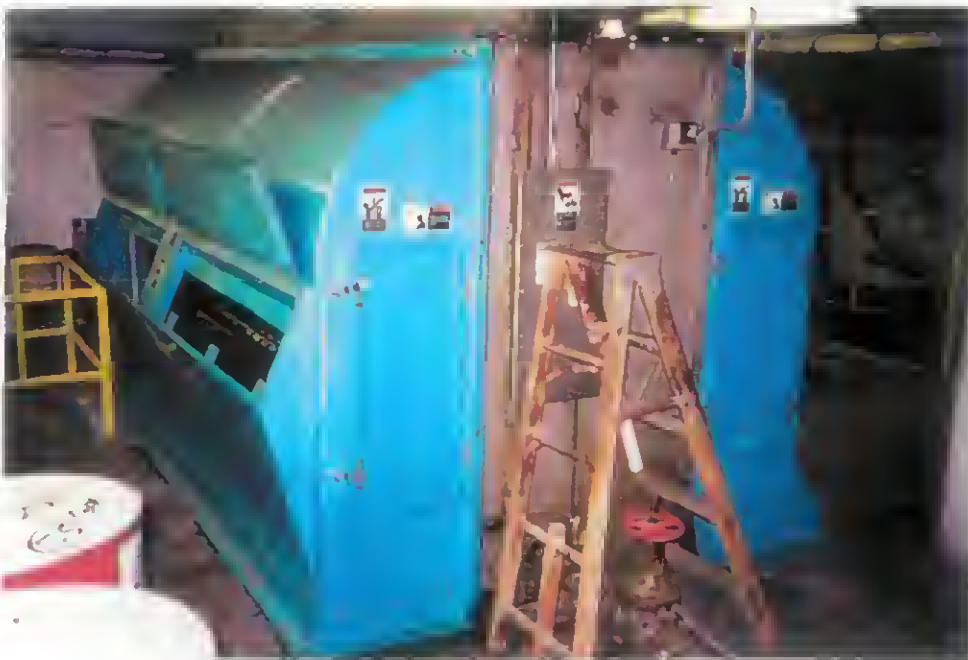
Photograph 1

River water pumps
in the remote
pumping station

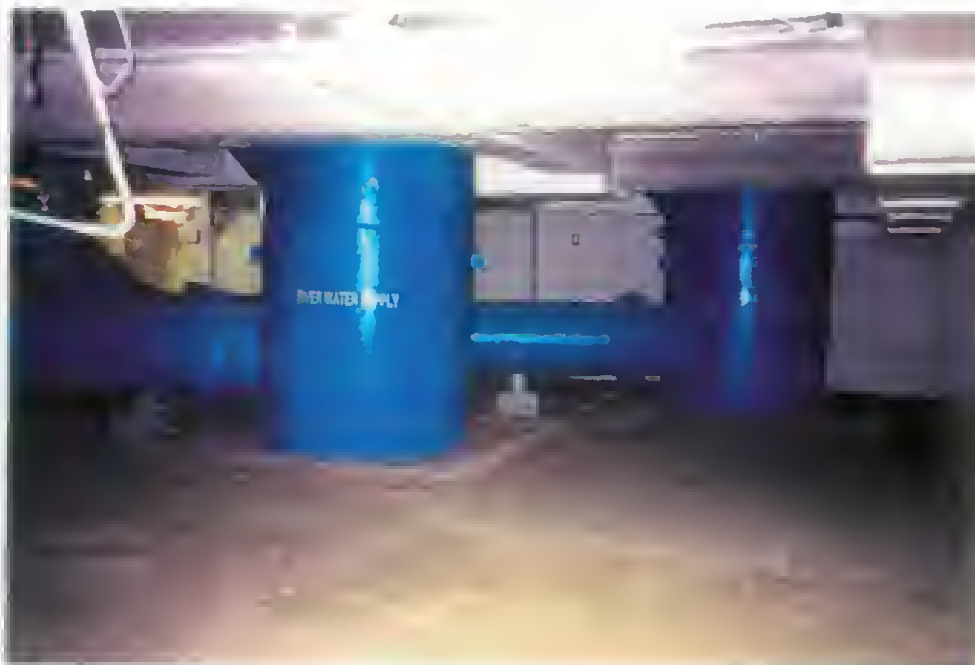
Photograph 2

Traveling screen
filter for the
river water
system

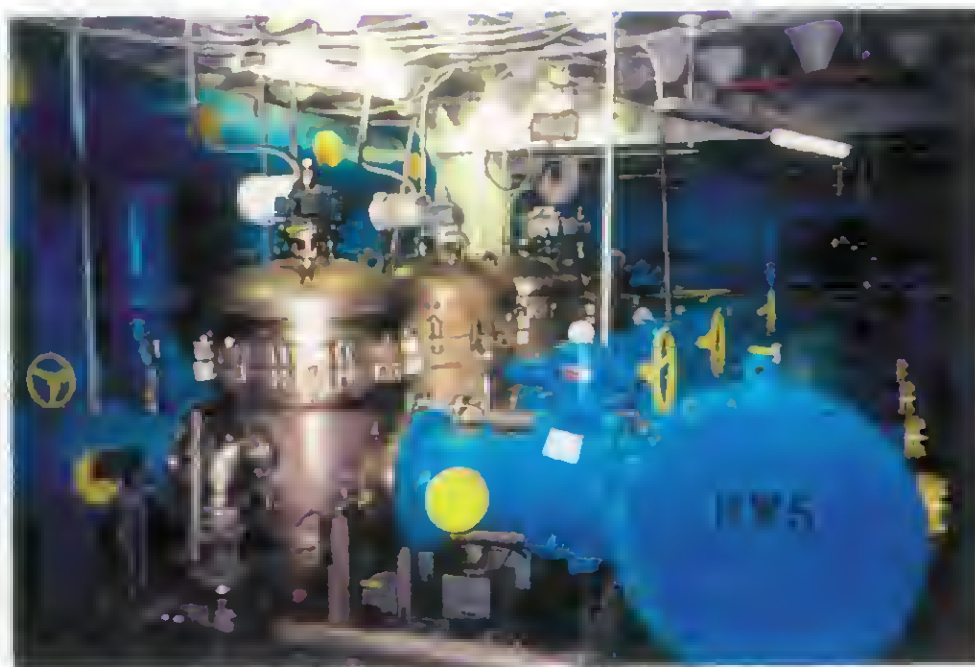
Photograph 3

River water
piping within the
complex

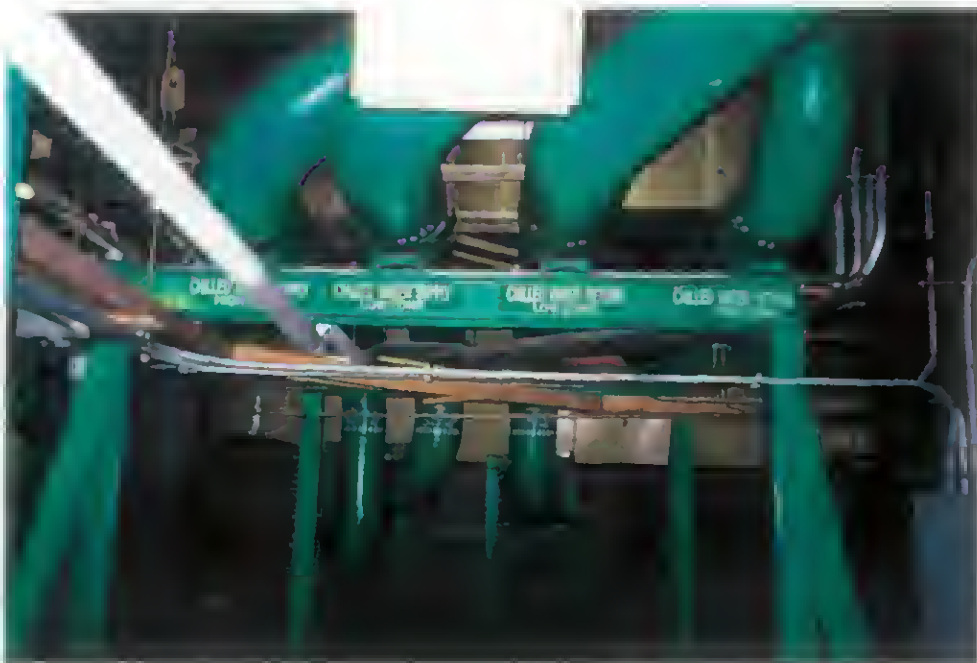
Photograph 7

Chilled water
pumps

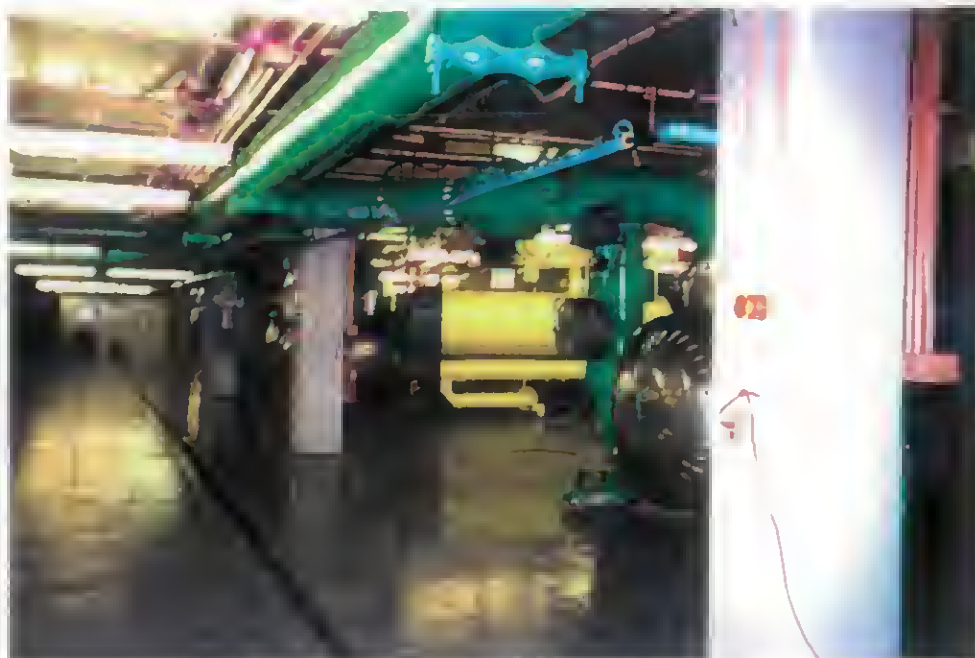
Photograph 8

High and low
zone chilled
water piping
